Manhole Inspection Summary

Manhole # S03SS1014MH

Insp Date: **7/22/06 7:55 AM**

Location Address: **5616 PARK HEIGHTS AVE**

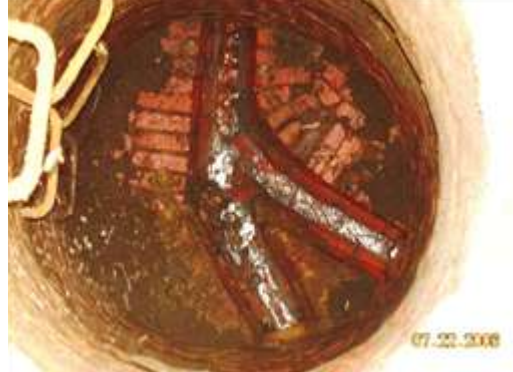
Top View

Frame leaks. Corbel and Barrel infiltration. Corroded steps. Evidence of surcharge - Bench debris. Channel

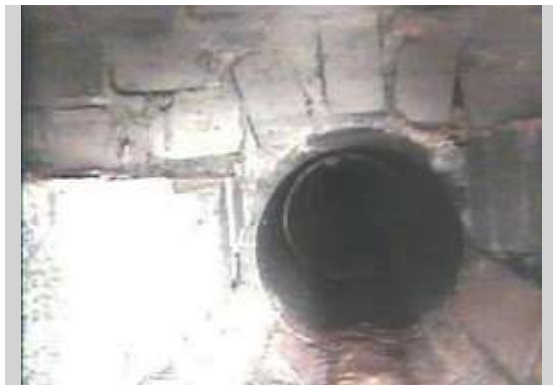
Pipe Out @ 12 O'Clock

8 in. Circular Gravity Sewer

Invert Depth: **11.60** (ft.) Flow Characteristics: **Slow**

Infiltration: **Evidence** Pipe Seal Cond: **Unknown**

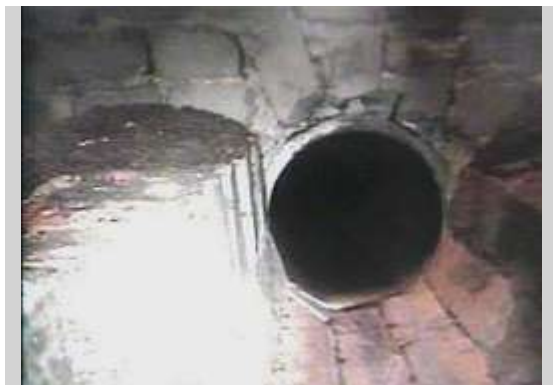
Pipe In @ 3 O'Clock

8 in. Circular Gravity Sewer

Invert Depth: **11.48** (ft.) Flow Characteristics: **Slow**

Infiltration: **Evidence** Pipe Seal Cond: **Cracked**

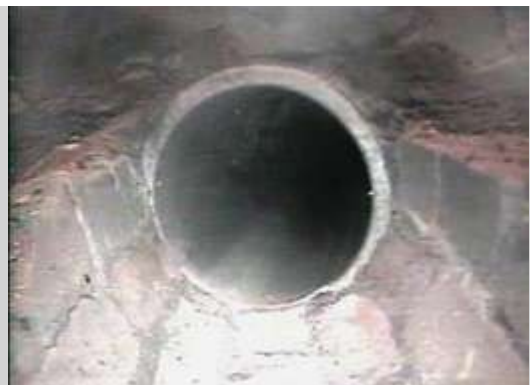
Pipe In @ 5 O'Clock

8 in. Circular Gravity Sewer

Invert Depth: **11.33** (ft.) Flow Characteristics: **None**

Connects To: **House connection / Service line**
